## **THESIS**

**IMAGING GALLIUM NITRIDE HIGH ELECTRON  
MOBILITY TRANSISTORS TO IDENTIFY POINT  
DEFECTS**

March 2014

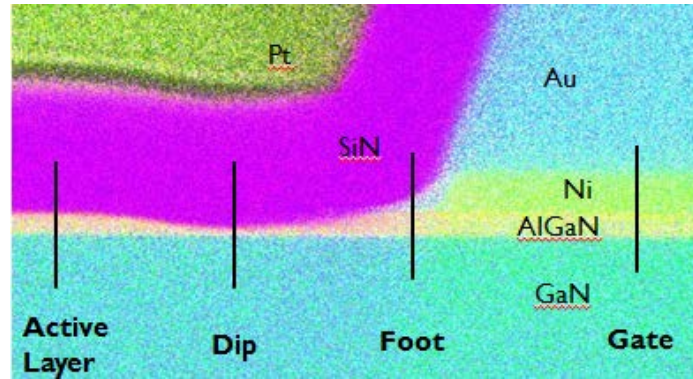
Figure 1. Ni/Au gate edge with four line scan areas labeled.

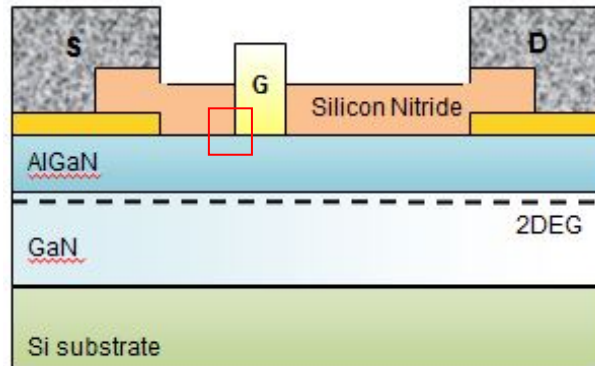
The GaN HEMT takes advantage of the intrinsically superior performance of GaN while utilizing a secondary effect of lattice mismatch, which occurs at the interface between GaN and (Al, Ga)N alloys of varying Al composition. This lattice mismatch between two layers of GaN and (Al, Ga)N creates a lattice strain thus generating a charge via the piezoelectric effect as discussed in [8]. The resulting charge is proportional to the mole fraction  $x$  of Al in the  $\text{Al}_x\text{Ga}_{1-x}\text{N}$  material where  $x$  must be less than 30 percent [4]. Polarization charge is produced at the heterojunction between the two layers. Free electrons concentrate near the polarization region to electrostatically screen the polarization charge, creating a two dimensional gas (2DEG) region at the GaN/(Al, Ga)N interface [11],[13]. The 2DEG region is visible in Figure 1 and denoted by the dotted line.

Figure 1. GaN HEMT with focus area highlighted and material layer types identified (from [15]).

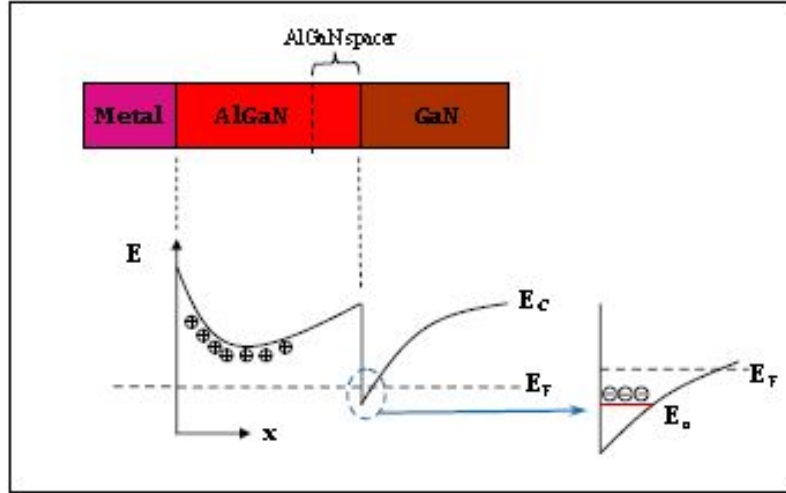
Figure 2. Energy Band diagram displaying 2DEG area (from [9]).

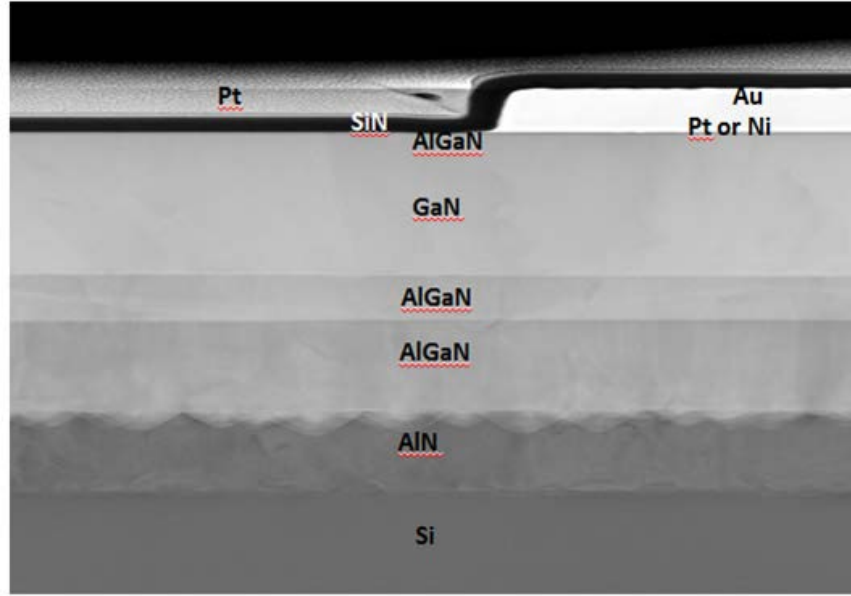
Figure 3. SEM image of cross section of the HEMT focused at the gate edge from Figure 2 denoted by the red box.

The AlN nucleation layer acts as a bonding layer between the Si substrate and the GaN layer to avoid a high coefficient of thermal expansion (CTE) mismatch between the Si and the GaN. This AlN layer prevents defects from arising during the high temperature growth procedure [4]. As seen in Figure 3, the layers furthest away from the Si substrate in the SEM image of the buffer layers shows the lattice strain lessens as the growth continues upwards. In addition, there are also far less visible dislocations in the GaN layer versus the AlN layer.

The two (Al, Ga)N layers following the nucleation layer are considered buffer layers to further reduce the strain of the active GaN layer. The decreasing concentration of visual dislocations between the two buffer layers is illustrated in Figure 3. The CTE mismatch between (Al, Ga)N and GaN layers is even lower, providing for a more stable and reliable device. Specifically, these layers reduce the leakage current through the GaN buffer, resulting in overall higher device efficiency and reliability.

Nominally, the vertical growth of the epitaxial regions is finalized with a GaN protective cap above the (Al,Ga)N region shown in Figure 3. This layer is very thin and important to ensure proper device functionality. This thin layer seals off hanging bonds of the (Al, Ga)N layer effectively “healing” the surface. Second, the layer increases the effective Schottky barrier height reducing gate leakage currents. Note the top GaN layer can act as a passivation layer when it is thick enough, precluding the need for a  $\text{Si}_3\text{N}_4$  passivation layer [4].

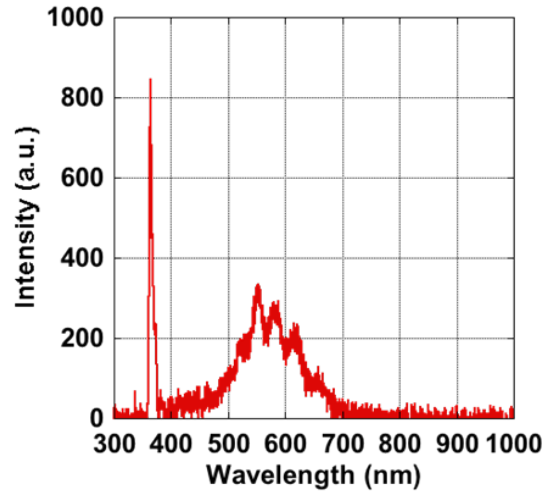
Figure 5. Wavelength intensity of defected GaN region gives rise to photoluminescence evidence (from [15]).

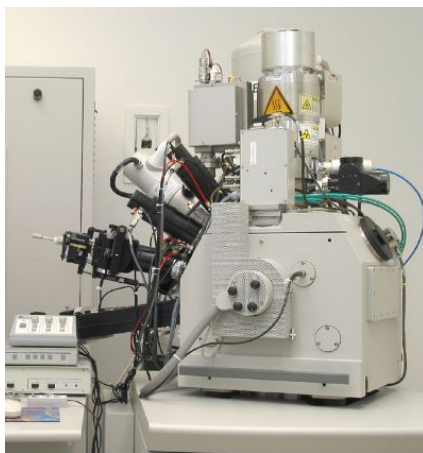
Figure 7. FIB with OmniProbe on the left with the SEM stack on the top.

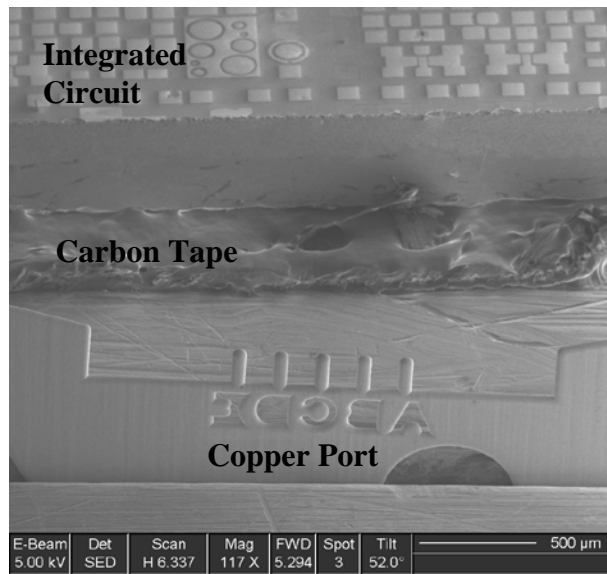
Figure 8. SEM image of five fingered copper port used to hold the lamella with the IC in the background with rolled carbon tape securing the IC.

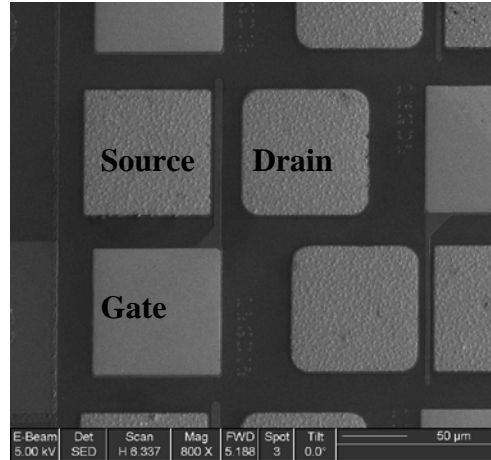
Figure 9. SEM image of properly aligned E-beam image indicating sample is at eucentric height and therefore focused.

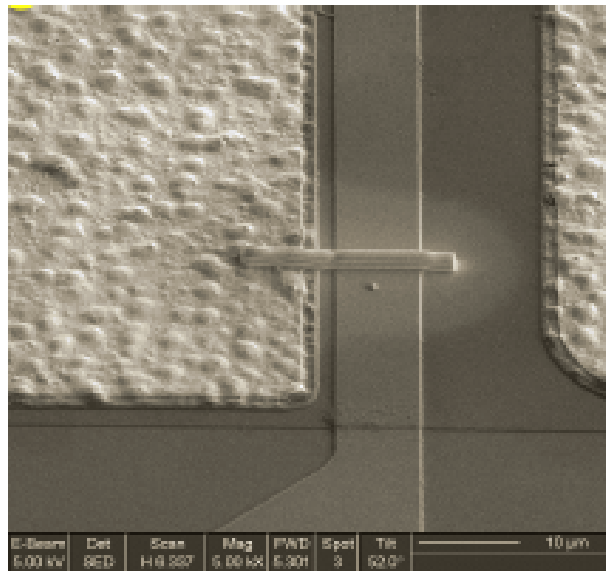
Figure 10. SEM image of  $1\mu\text{m}$  Pt protective layer over the device source edge and gate.

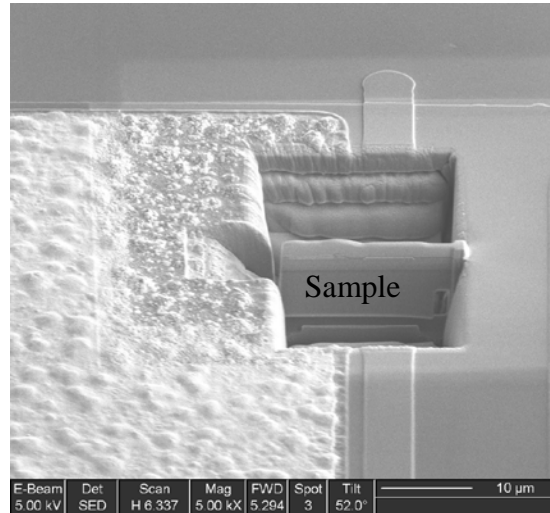
Figure 11. SEM image of 5 $\mu$ m deep trenches etched around the sample.

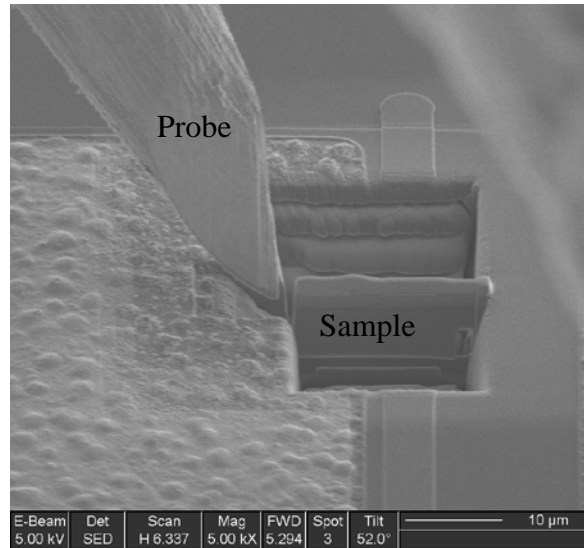
Figure 13. SEM image of OmniProbe shown in position for welding the sample.

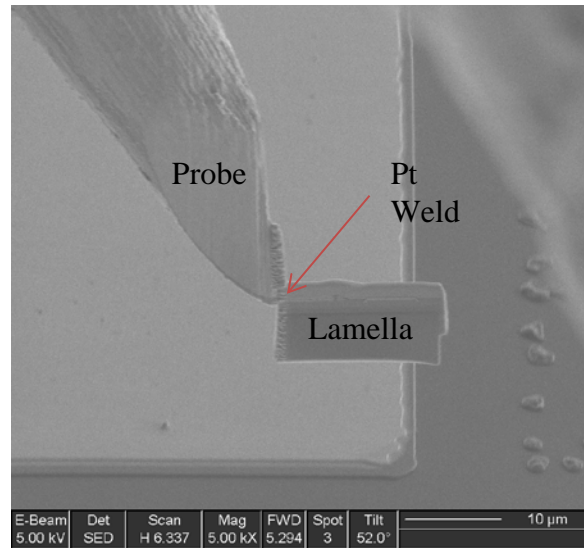
Figure 14. SEM image of lamella welded onto the probe with Pt.

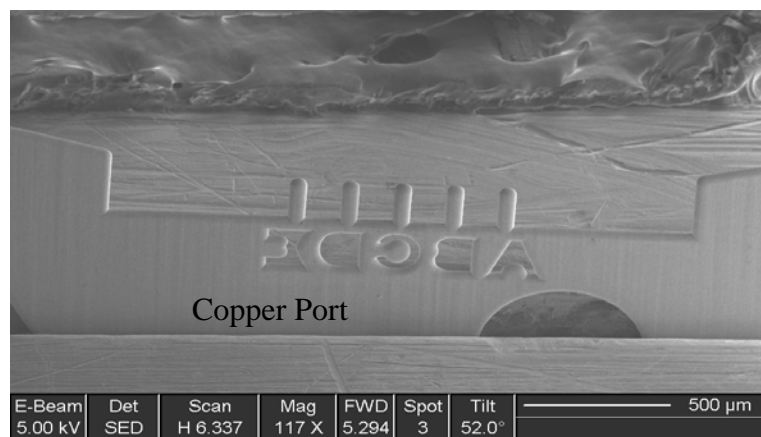
Figure 15. SEM image of the copper port properly mounted and in correct field of view. The orientation of the port is the same for every sample.

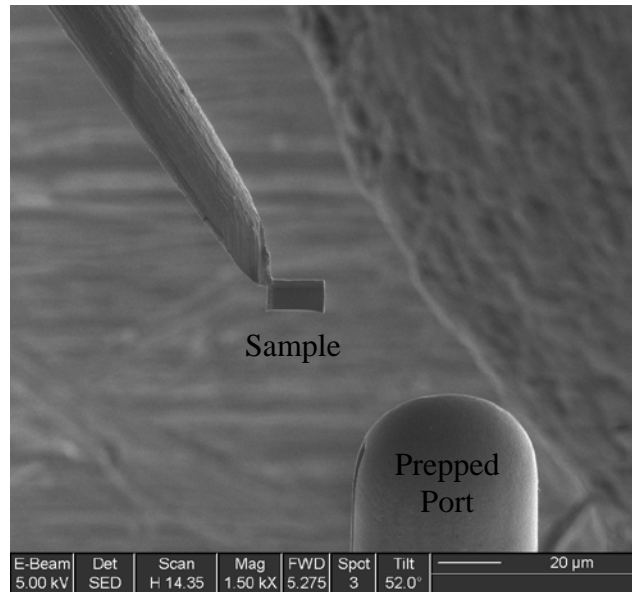
Figure 17. SEM image of welded sample moving into position to the prepped port.

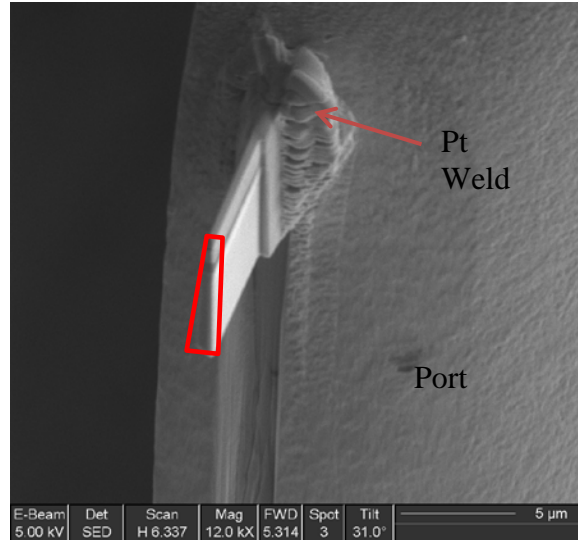
Figure 18. Final SEM image of the sample welded to the port. The top of the device is much thinner than the bottom creating a trapezoidal shape.

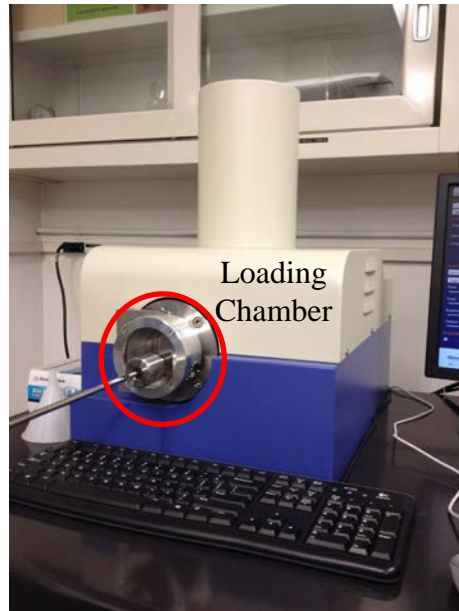
Figure 19. NanoMill machine with loading area in silver. There is a two-stage vacuum present, one to allow for the loading area and the other for the chamber itself.

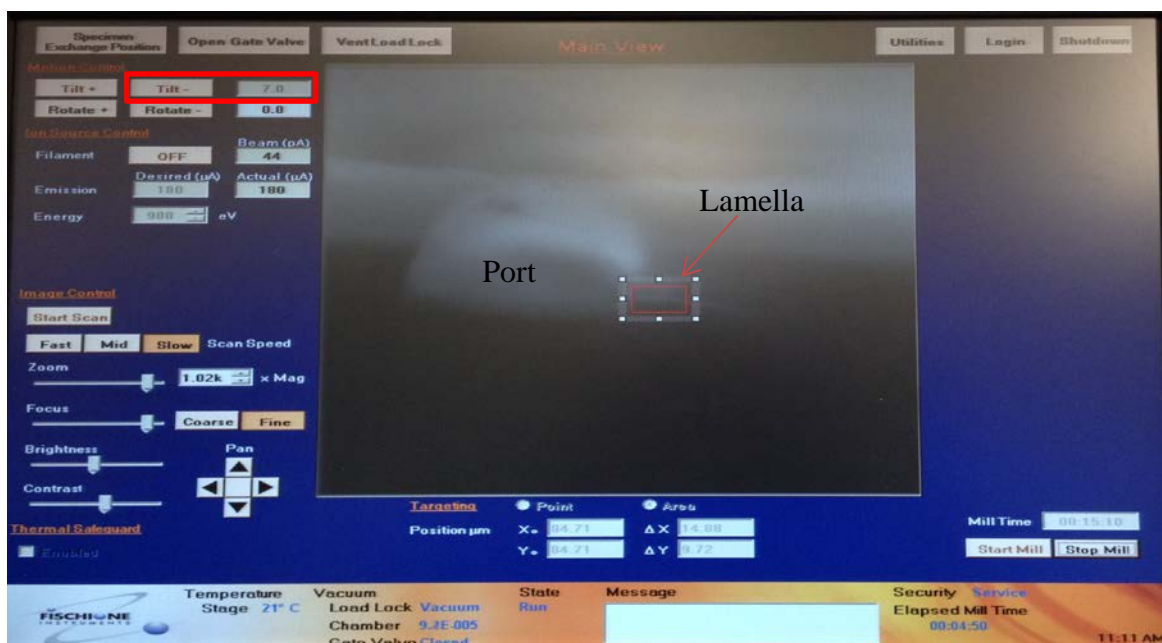
Figure 20. NanoMill control screen showing parameters for the milling process and monitor screen.

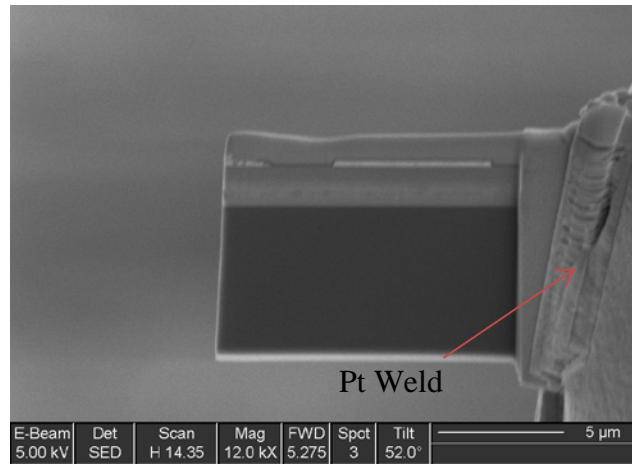
Figure 22. SEM image of sample properly welded, thinned and mounted to the port.

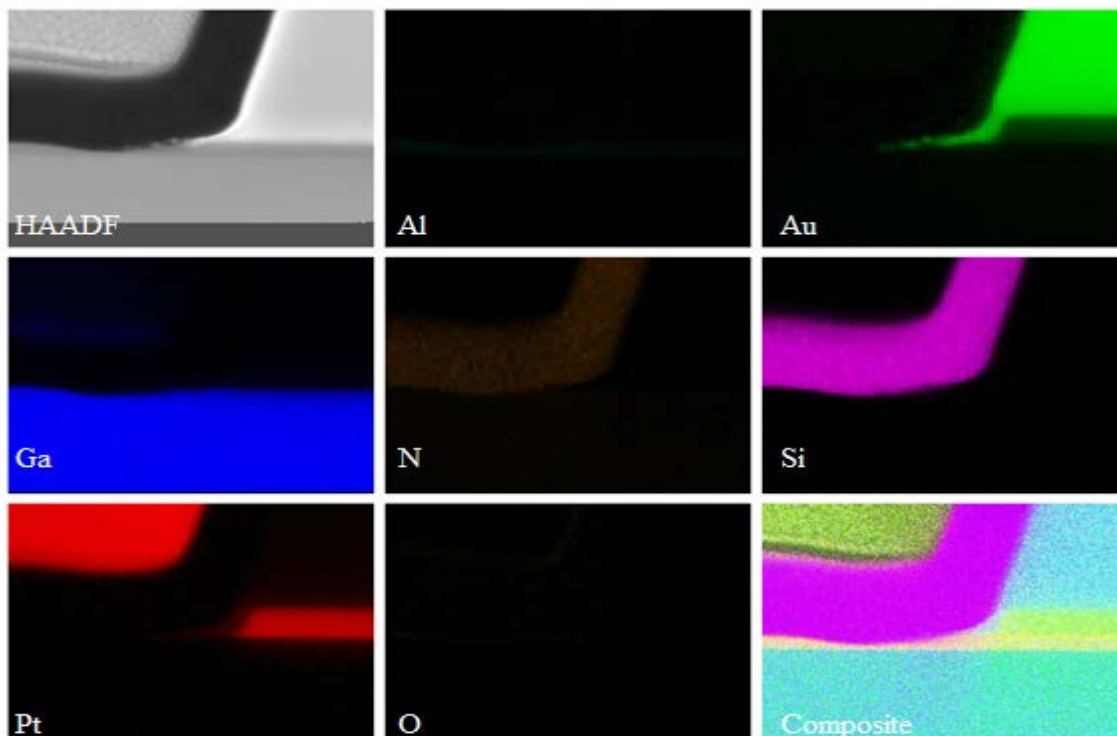
Figure 25. STEM image from the EDS of the fresh Pt gated device broken into each element of focus.

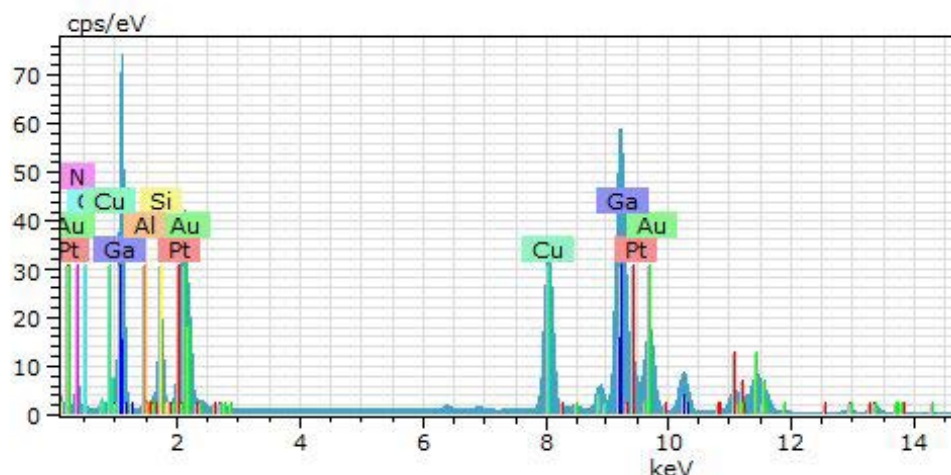
Figure 26. Elemental spectrum display of electron volts versus photon counts of the fresh Pt sample. The peaks in the spectrum correspond to individual elements present in imaged area.

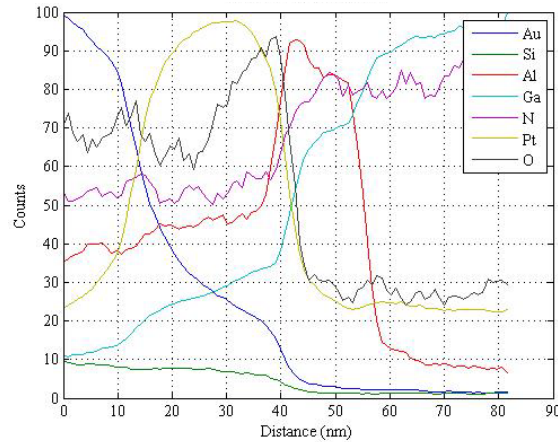
Figure 27. Line scan data from the fresh Pt gate line scan depicting the rise and fall of each element presence analyzed.

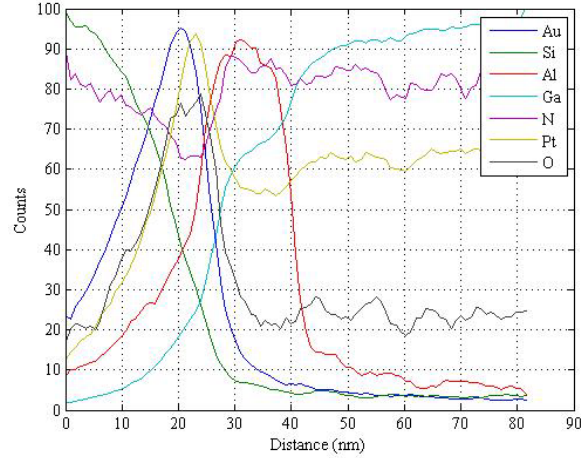
Figure 28. Line scan data from the fresh Pt foot line scan depicting the presence of each element analyzed.

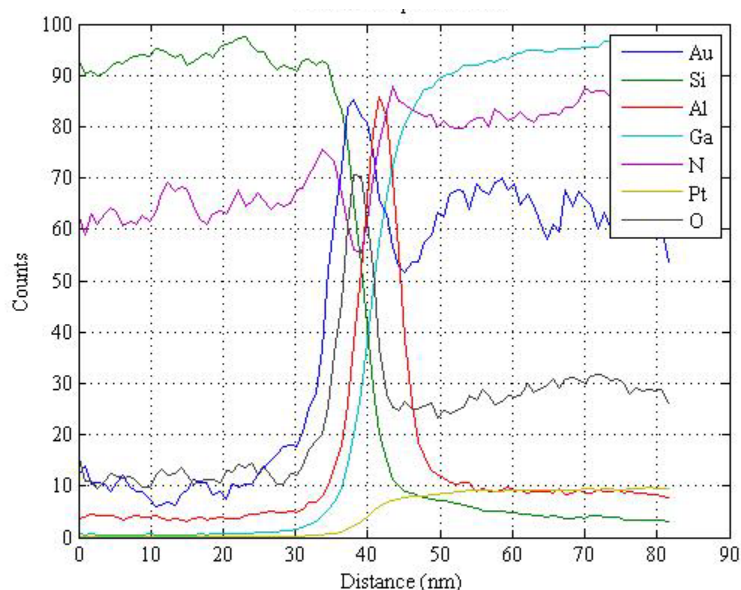
Figure 29. Line scan data from the fresh Pt dip line scan depicting the presence of each element analyzed.

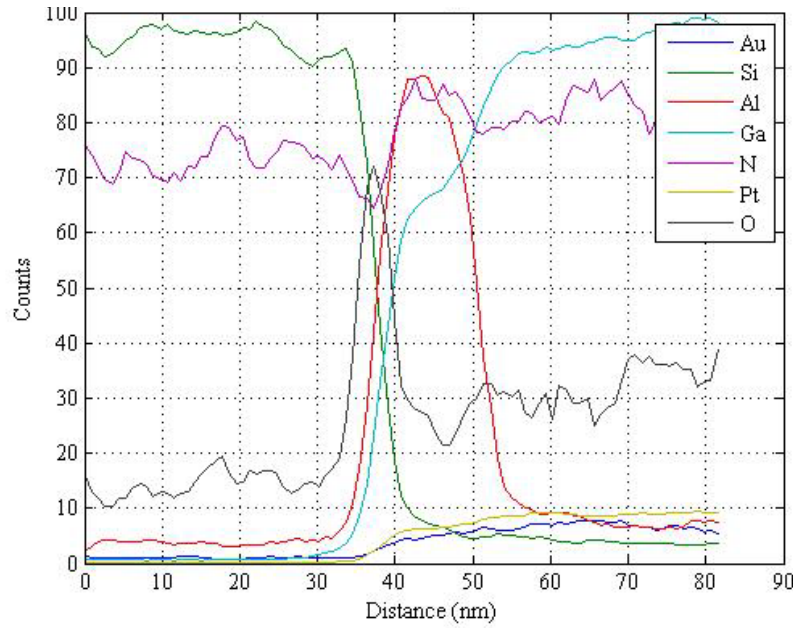
Figure 30. Line scan data from the fresh Pt Active layer line scan depicting the presence of each element analyzed.

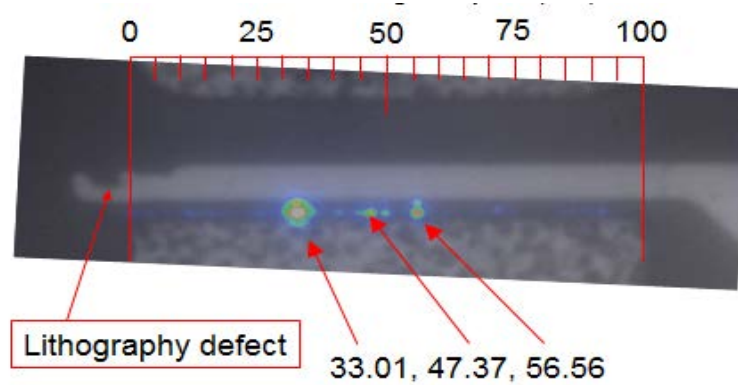
Figure 31. Electroluminescence intensity on degraded Pt gate. The arrows correspond to the distance across the gate in  $\mu\text{m}$  beginning at the edge of the source indicating areas of higher intensity.

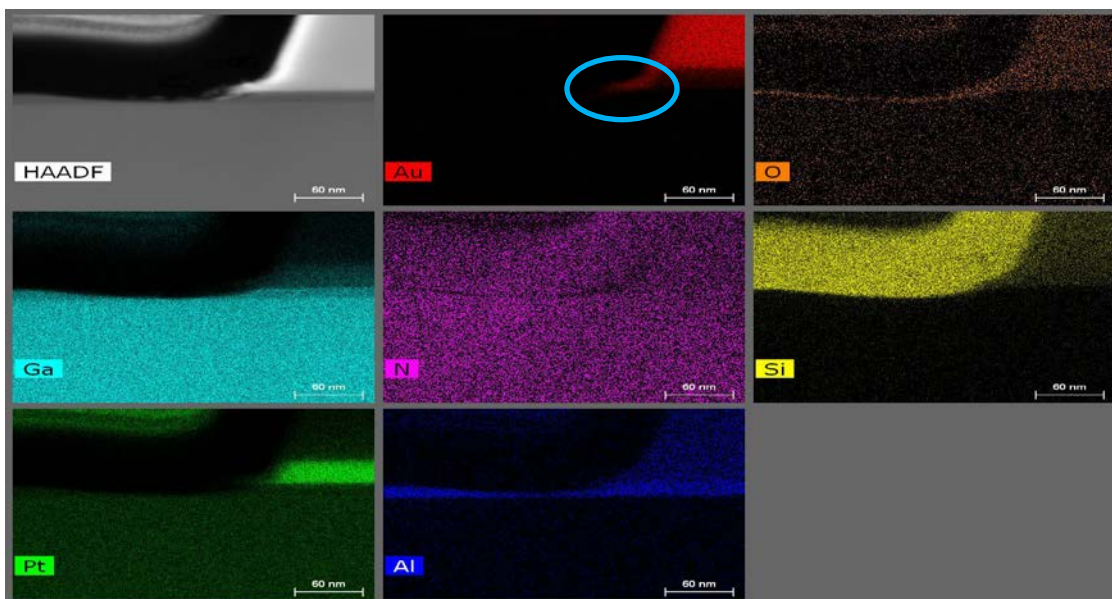
Figure 32. Elemental scans from the EDS for the degraded Pt device. The top left image is the HAADF followed by the seven singular elemental pictures (Au, O, Ga, N, Si, Pt, and Al).

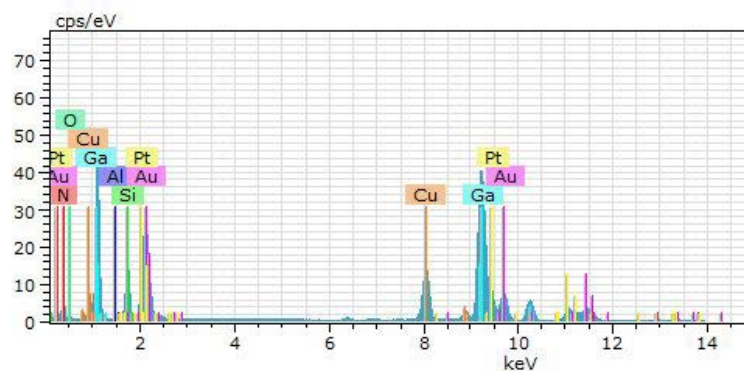
Figure 33. Elemental spectrum display of electron volts versus photon counts of the degraded Pt sample. The peaks in the spectrum correspond to individual elements present in imaged area.

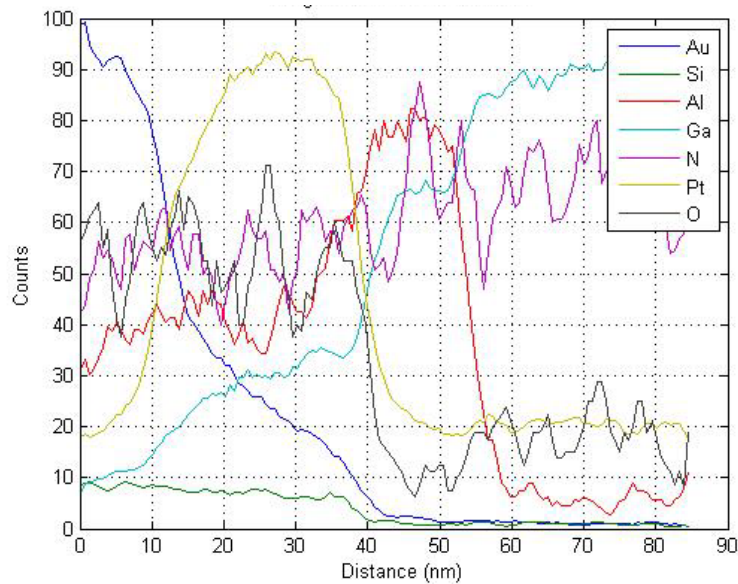
Figure 34. Line scan data of the degraded Pt gate line scan depicting the presence of each element analyzed.

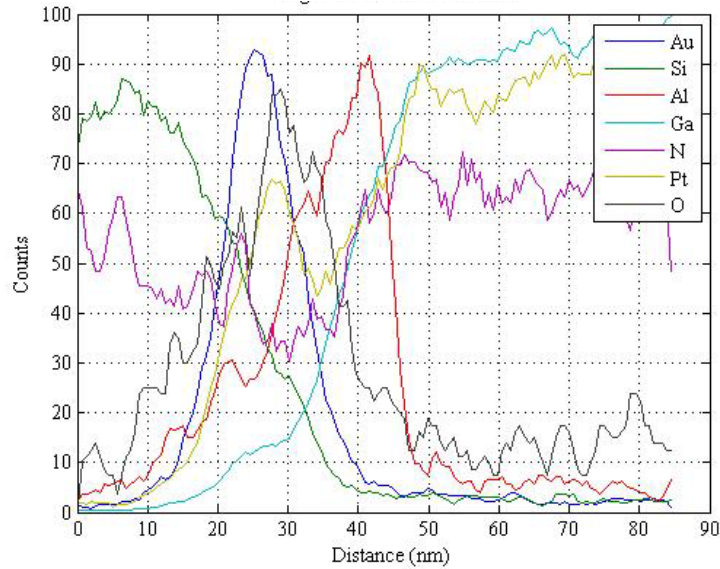
Figure 35. Line scan data of the degraded Pt foot line scan depicting the presence of each element analyzed.

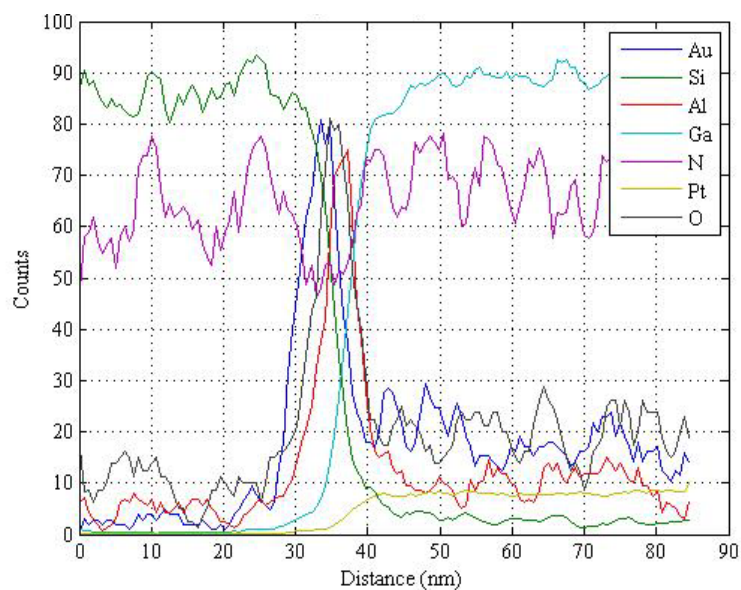
Figure 36. Line scan data from the degraded Pt dip line scan depicting the presence of each element analyzed.

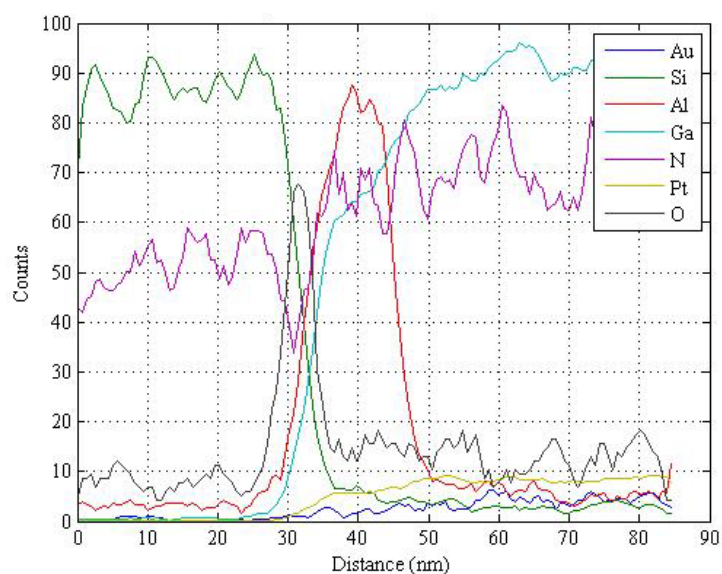
Figure 37. Line scan data of the degraded Pt active layer line scan depicting the presence of each element analyzed.

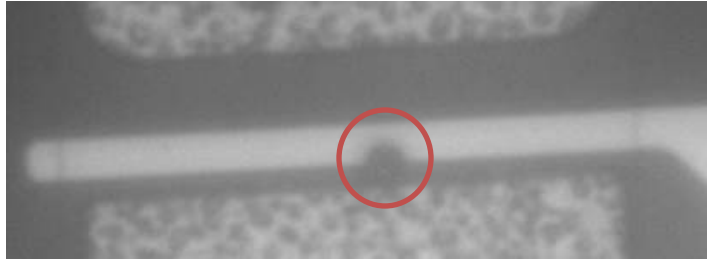
Figure 38. SEM image from NRL of failed Pt device after catastrophic failure. The breakdown area is circled in red.

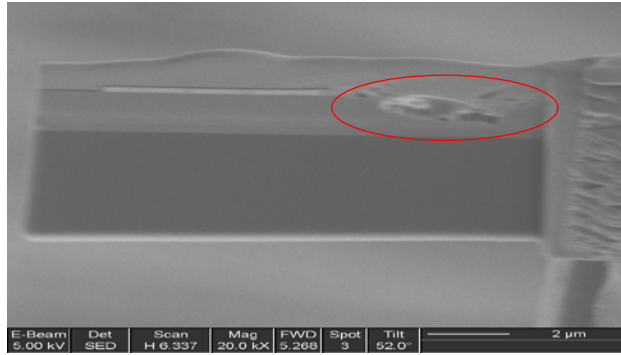
Figure 39. SEM image of failed Pt device sample with large defect circled in red.

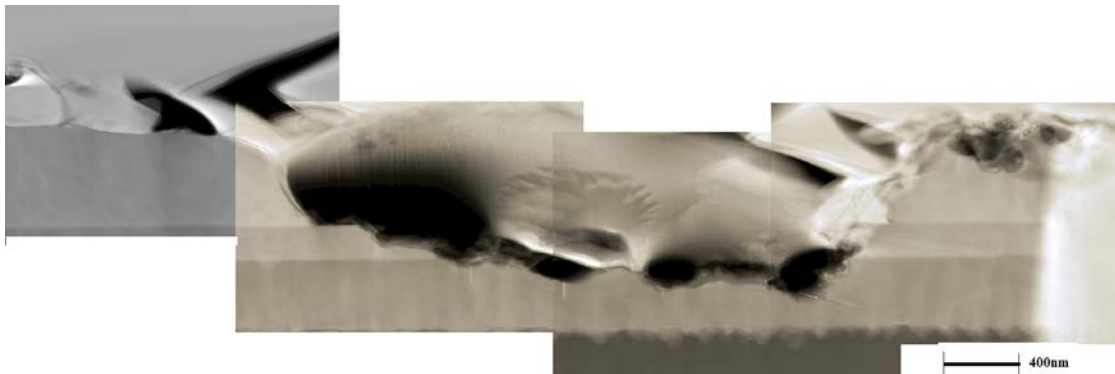
Figure 40. STEM composite image of the failed Pt device sample focused on the large defect area.

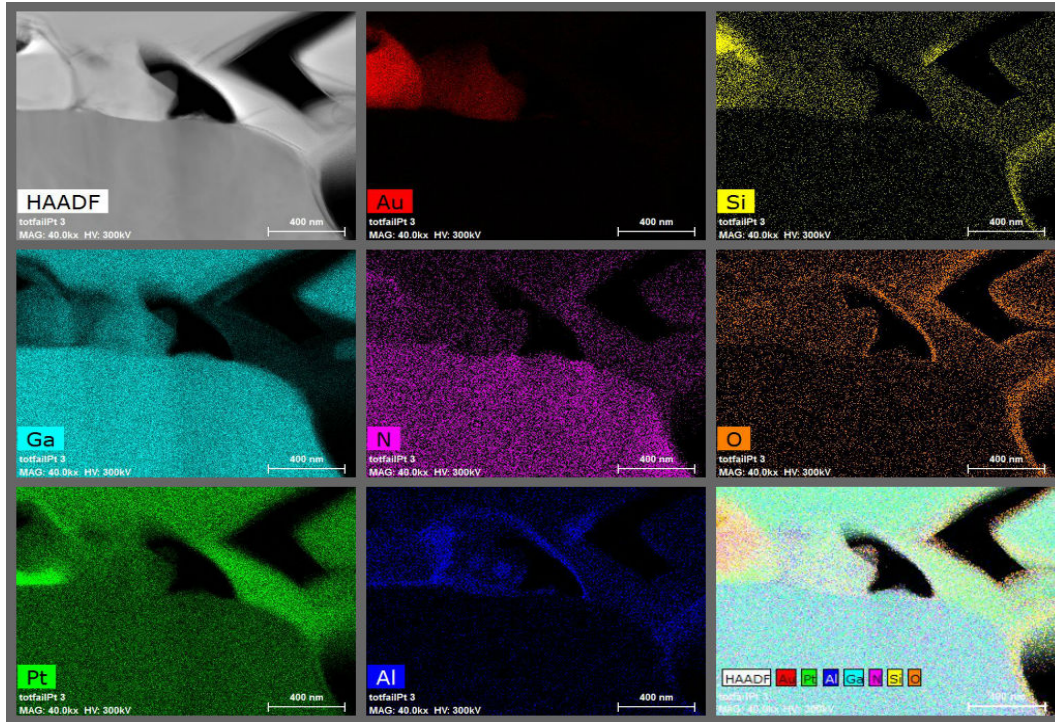
Figure 41. Elemental scans from the EDS for the failed Pt gate on the source side with major degradation of the gate edge. The first image is the HAADF followed by the seven singular elemental pictures (Au, O, Ga, N, Si, Pt, and Al).

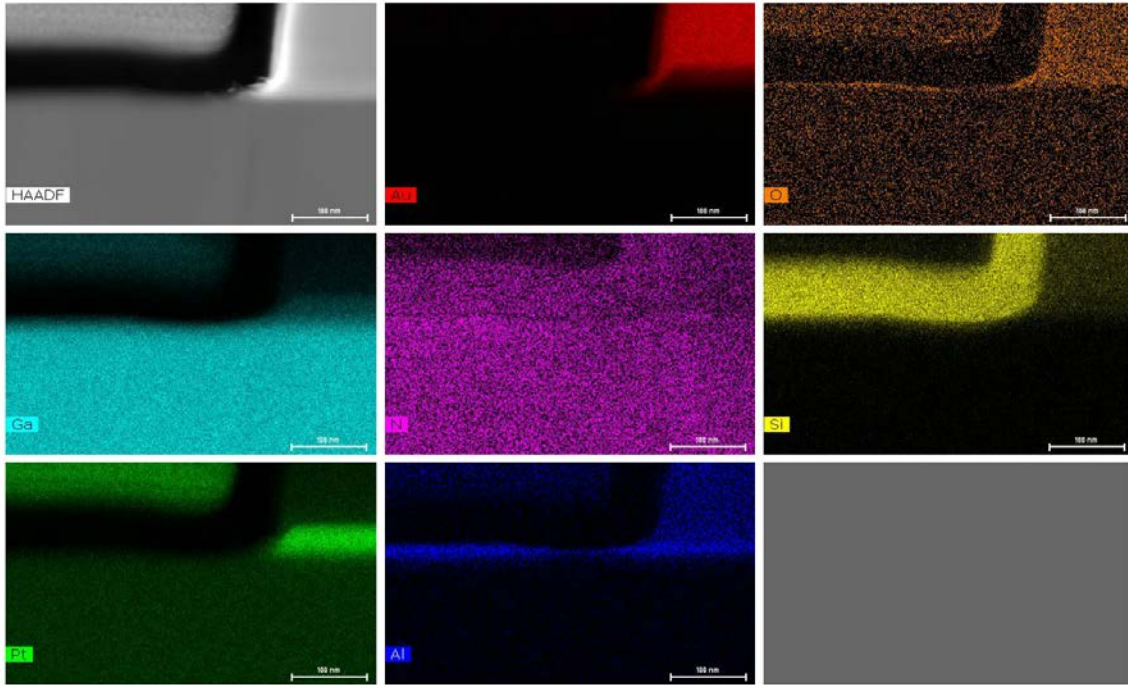
Figure 42. Elemental scans from the EDS for the failed Pt gated device. The first image is the HAADF followed by the seven singular elemental pictures (Au, O, Ga, N, Si, Pt, and Al).

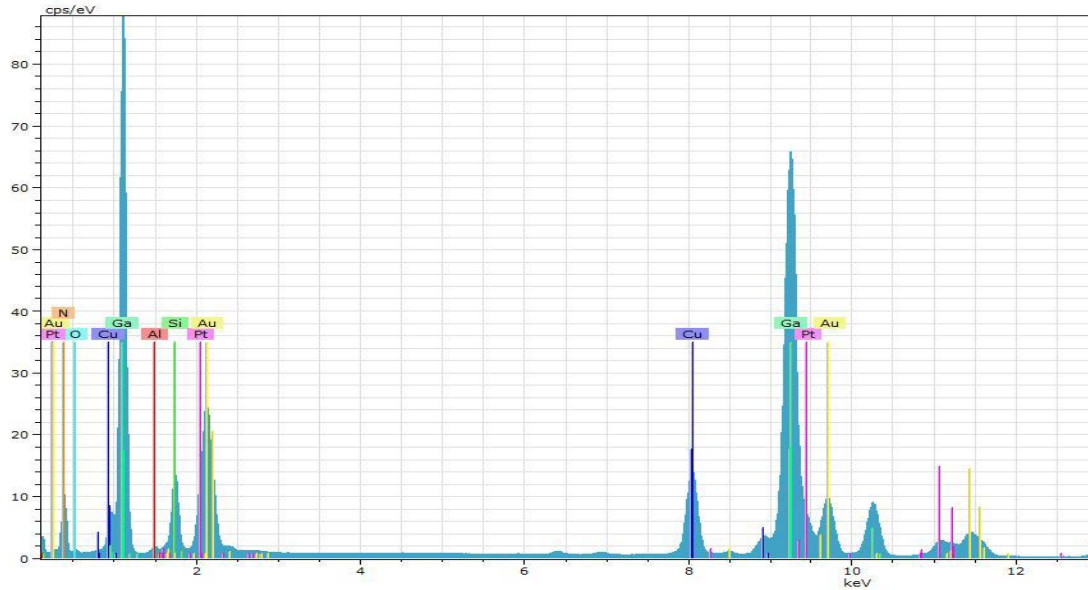
Figure 43. Elemental spectrum display of electron volts versus photon counts of the failed Pt sample. The peaks in the spectrum correspond to individual elements present in imaged area.

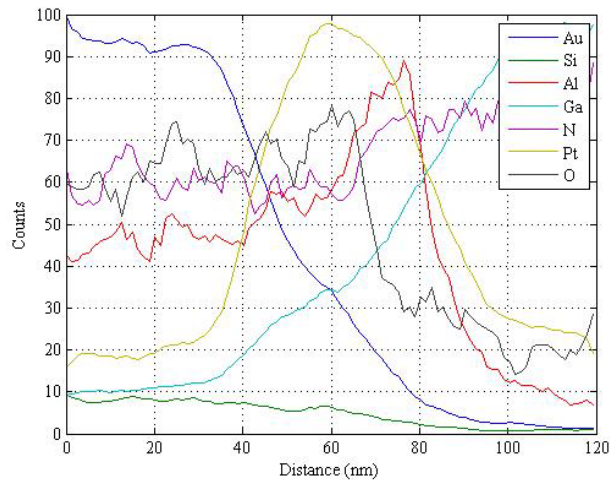
Figure 44. Line scan data for the failed Pt gate line scan depicting the presence of each element analyzed.

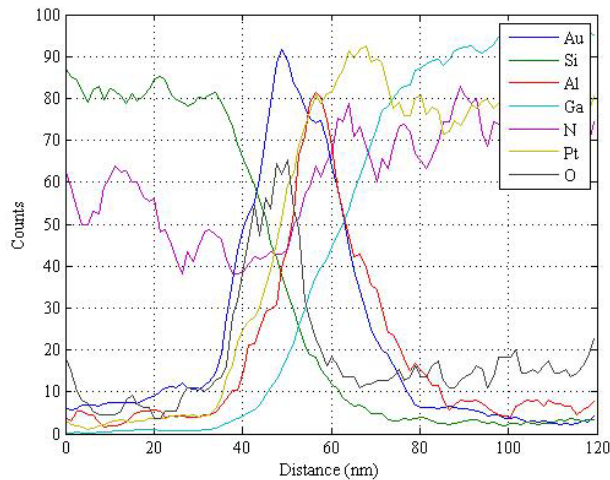
Figure 45. Line scan data of the failed Pt foot line scan depicting the presence of each element analyzed.

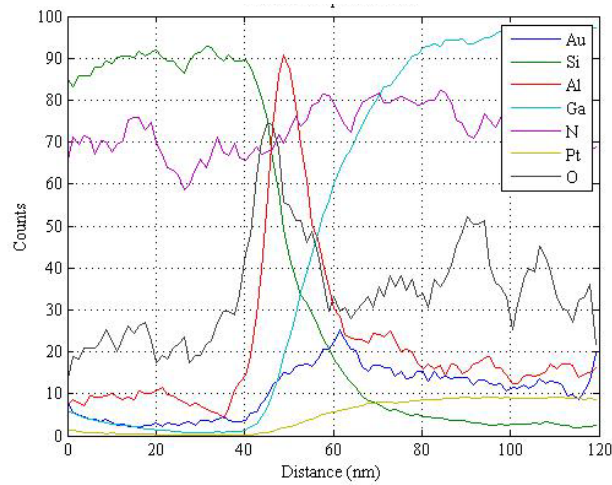
Figure 46. Line scan data of the failed Pt dip line scan depicting the presence of each element analyzed.

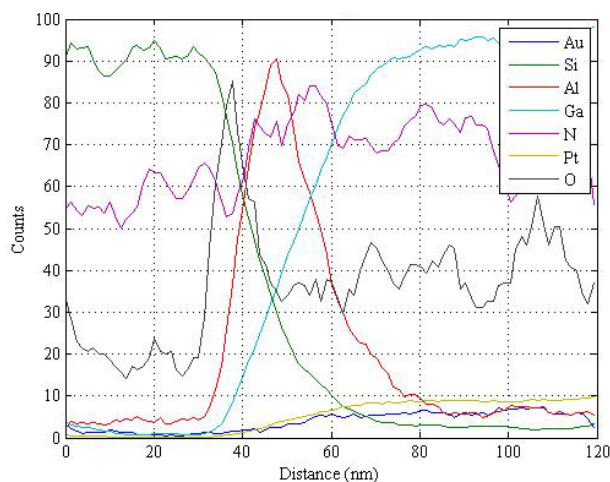
Figure 47. Line scan data of the failed Pt active layer line scan depicting the presence of each element analyzed.

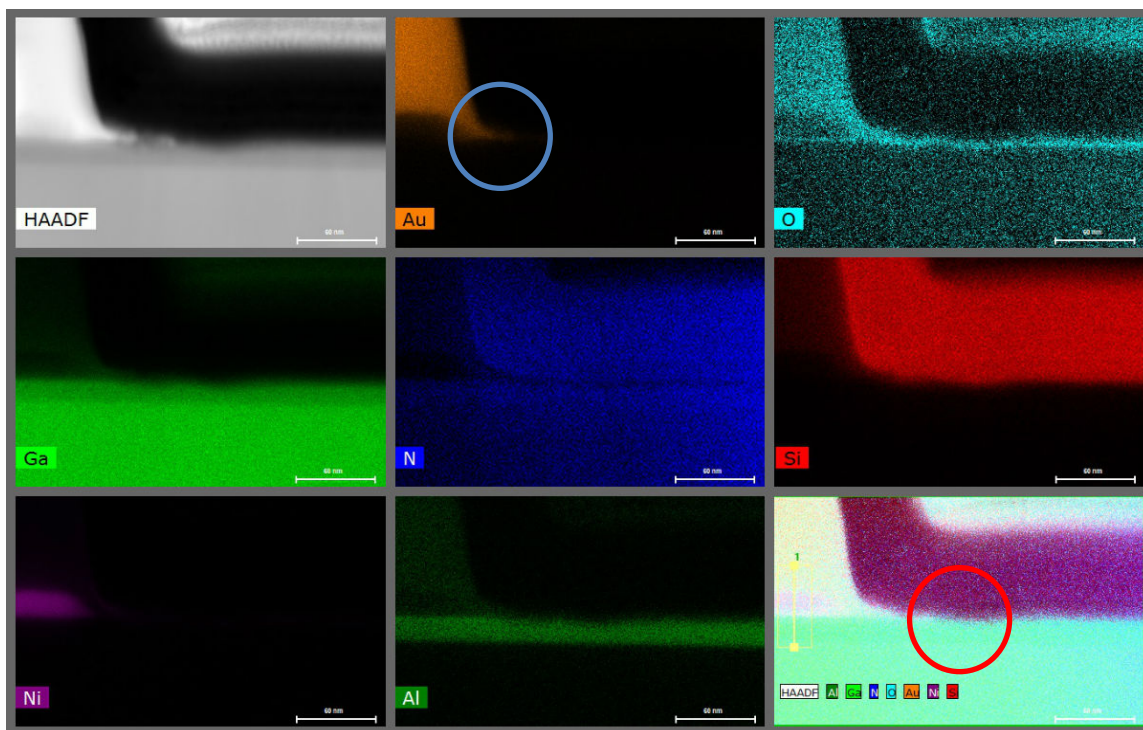
Figure 48. Elemental scans from the EDS for the fresh Ni gated device. The First image is the HAADF followed by the seven singular elemental pictures (Au, O, Ga, N, Si, Ni, and Al), ending with the composite picture of those seven elements.

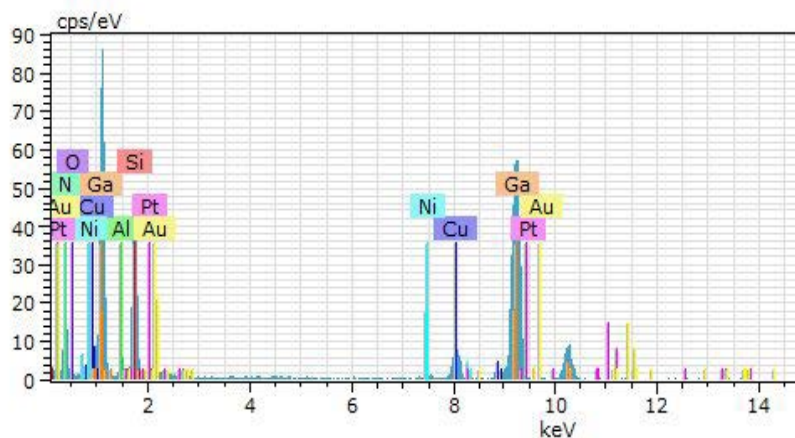
Figure 49. Elemental spectrum display of electron volts versus photon counts of the fresh Ni sample. The peaks in the spectrum correspond to individual elements present in imaged area.

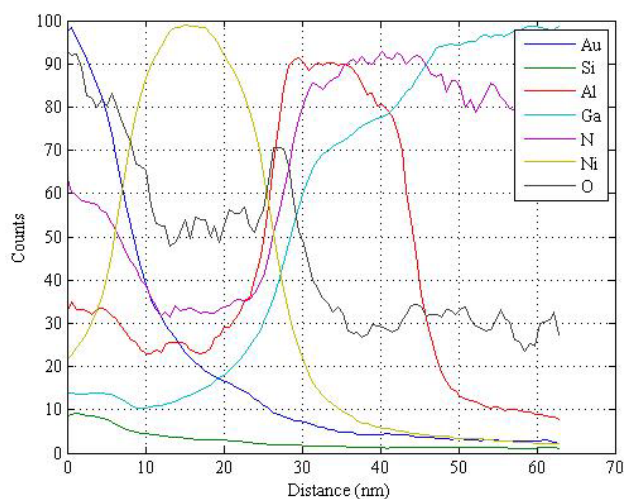
Figure 50. Line scan data for the fresh Ni gate line scan depicting the presence of each element analyzed.

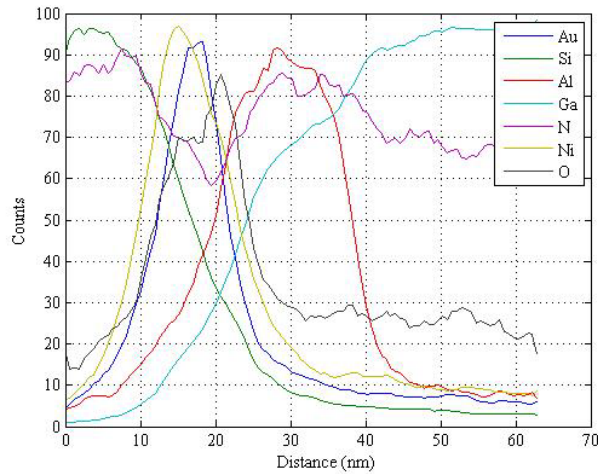
Figure 51. Line scan data for the fresh Ni foot line scan depicting the presence of each element analyzed.

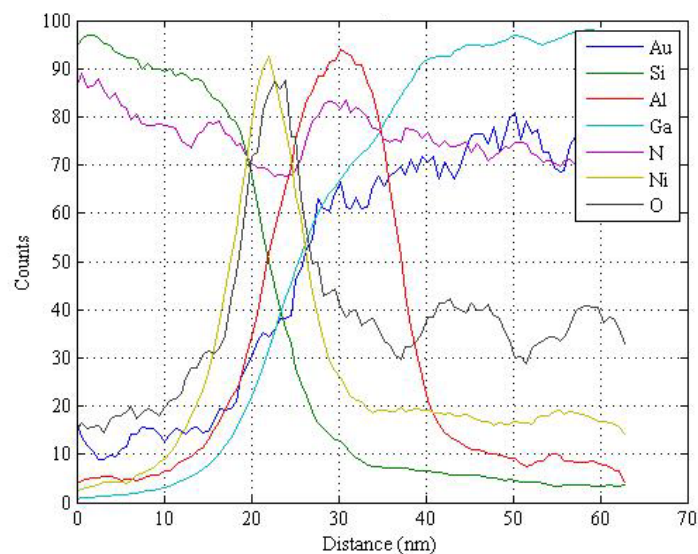
Figure 52. Line scan data of the fresh Ni dip line scan depicting the presence of each element analyzed.

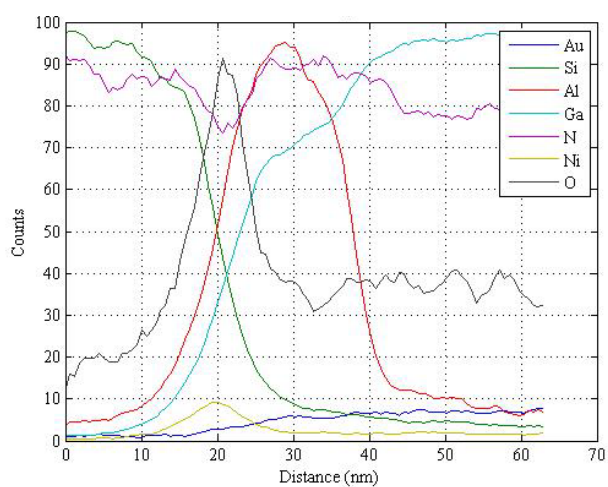
Figure 53. Line scan data of the fresh Ni active layer line scan depicting the presence of each element analyzed.

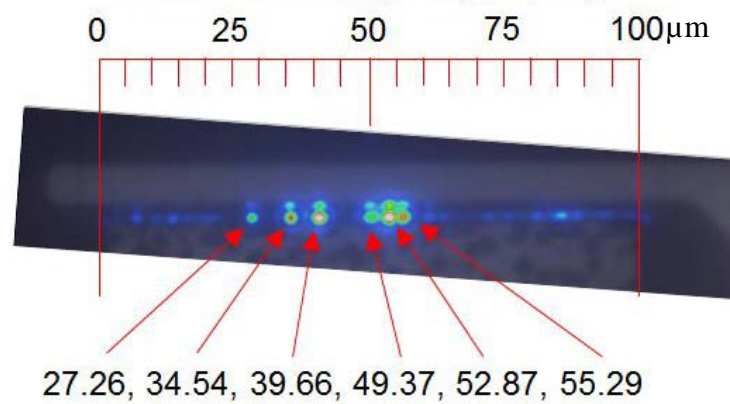
Figure 54. Electroluminescence after stressing on the degraded Ni gated HEMT. The arrows correspond to the distance across the gate in  $\mu m$  beginning at the edge of the source indicating areas of higher intensity.

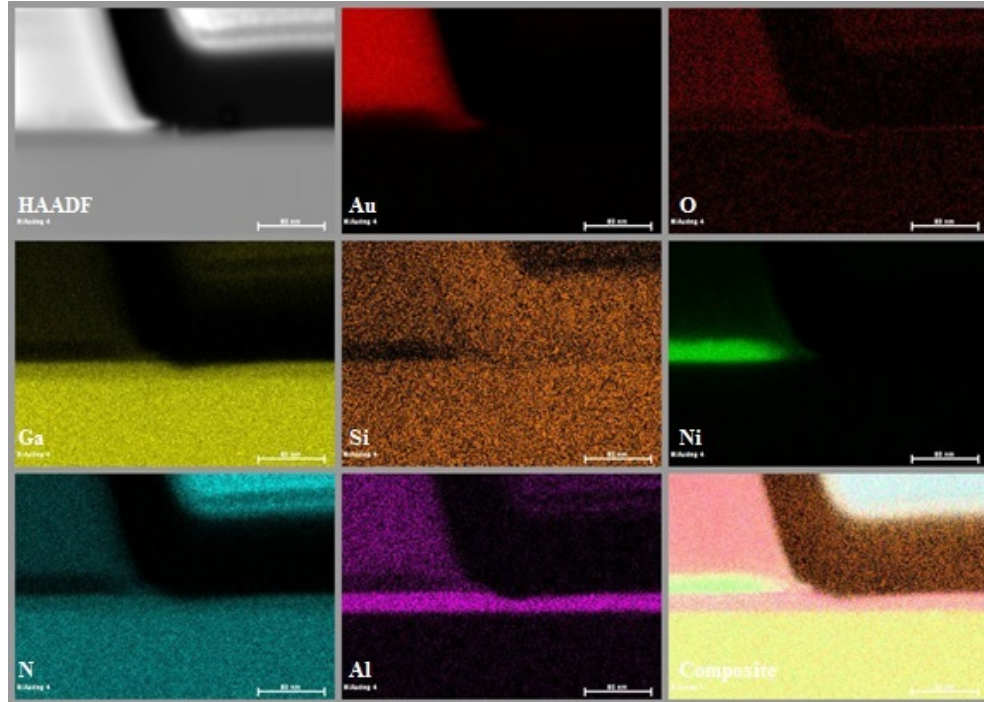
Figure 55. Elemental scans from the EDS for the degraded Ni gated device. The first image is the HAADF followed by the seven singular elemental pictures (Au, O, Ga, Si, Ni, N and Al), ending with the composite picture of those seven elements.

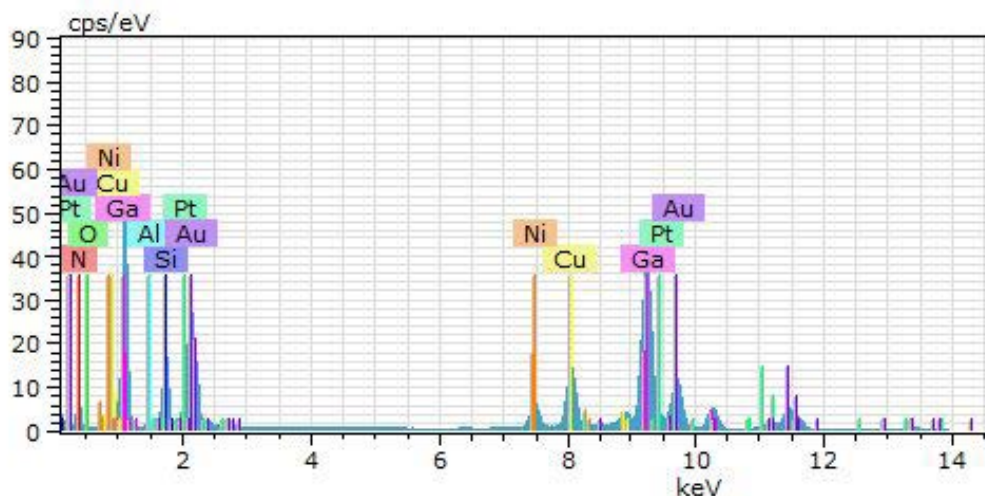
Figure 56. Elemental spectrum display of electron volts versus photon counts of the degraded Ni sample. The peaks in the spectrum correspond to individual elements present in imaged area.

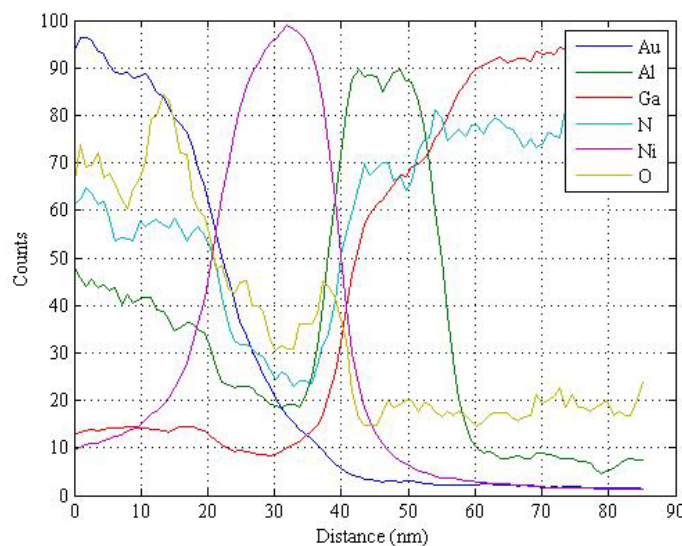
Figure 57. Line scan data of the degraded Ni gate line scan depicting the presence of each element analyzed.

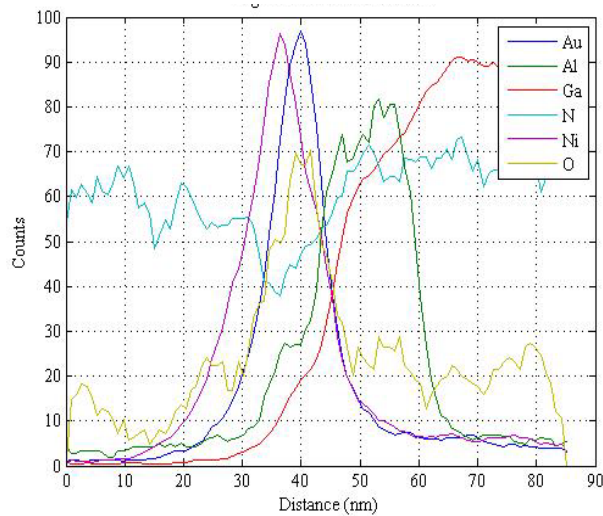
Figure 58. Line scan data of the degraded Ni foot line scan depicting the presence of each element analyzed.
